Notice to Navigation Interests

Condition of Federal Navigation Channel Sandusky Harbor, Sandusky, Ohio

SANDUSKY HARBOR, OHIO

CHANNEL CONDITIONS
AFTER FALL CONTRACT DREDGING

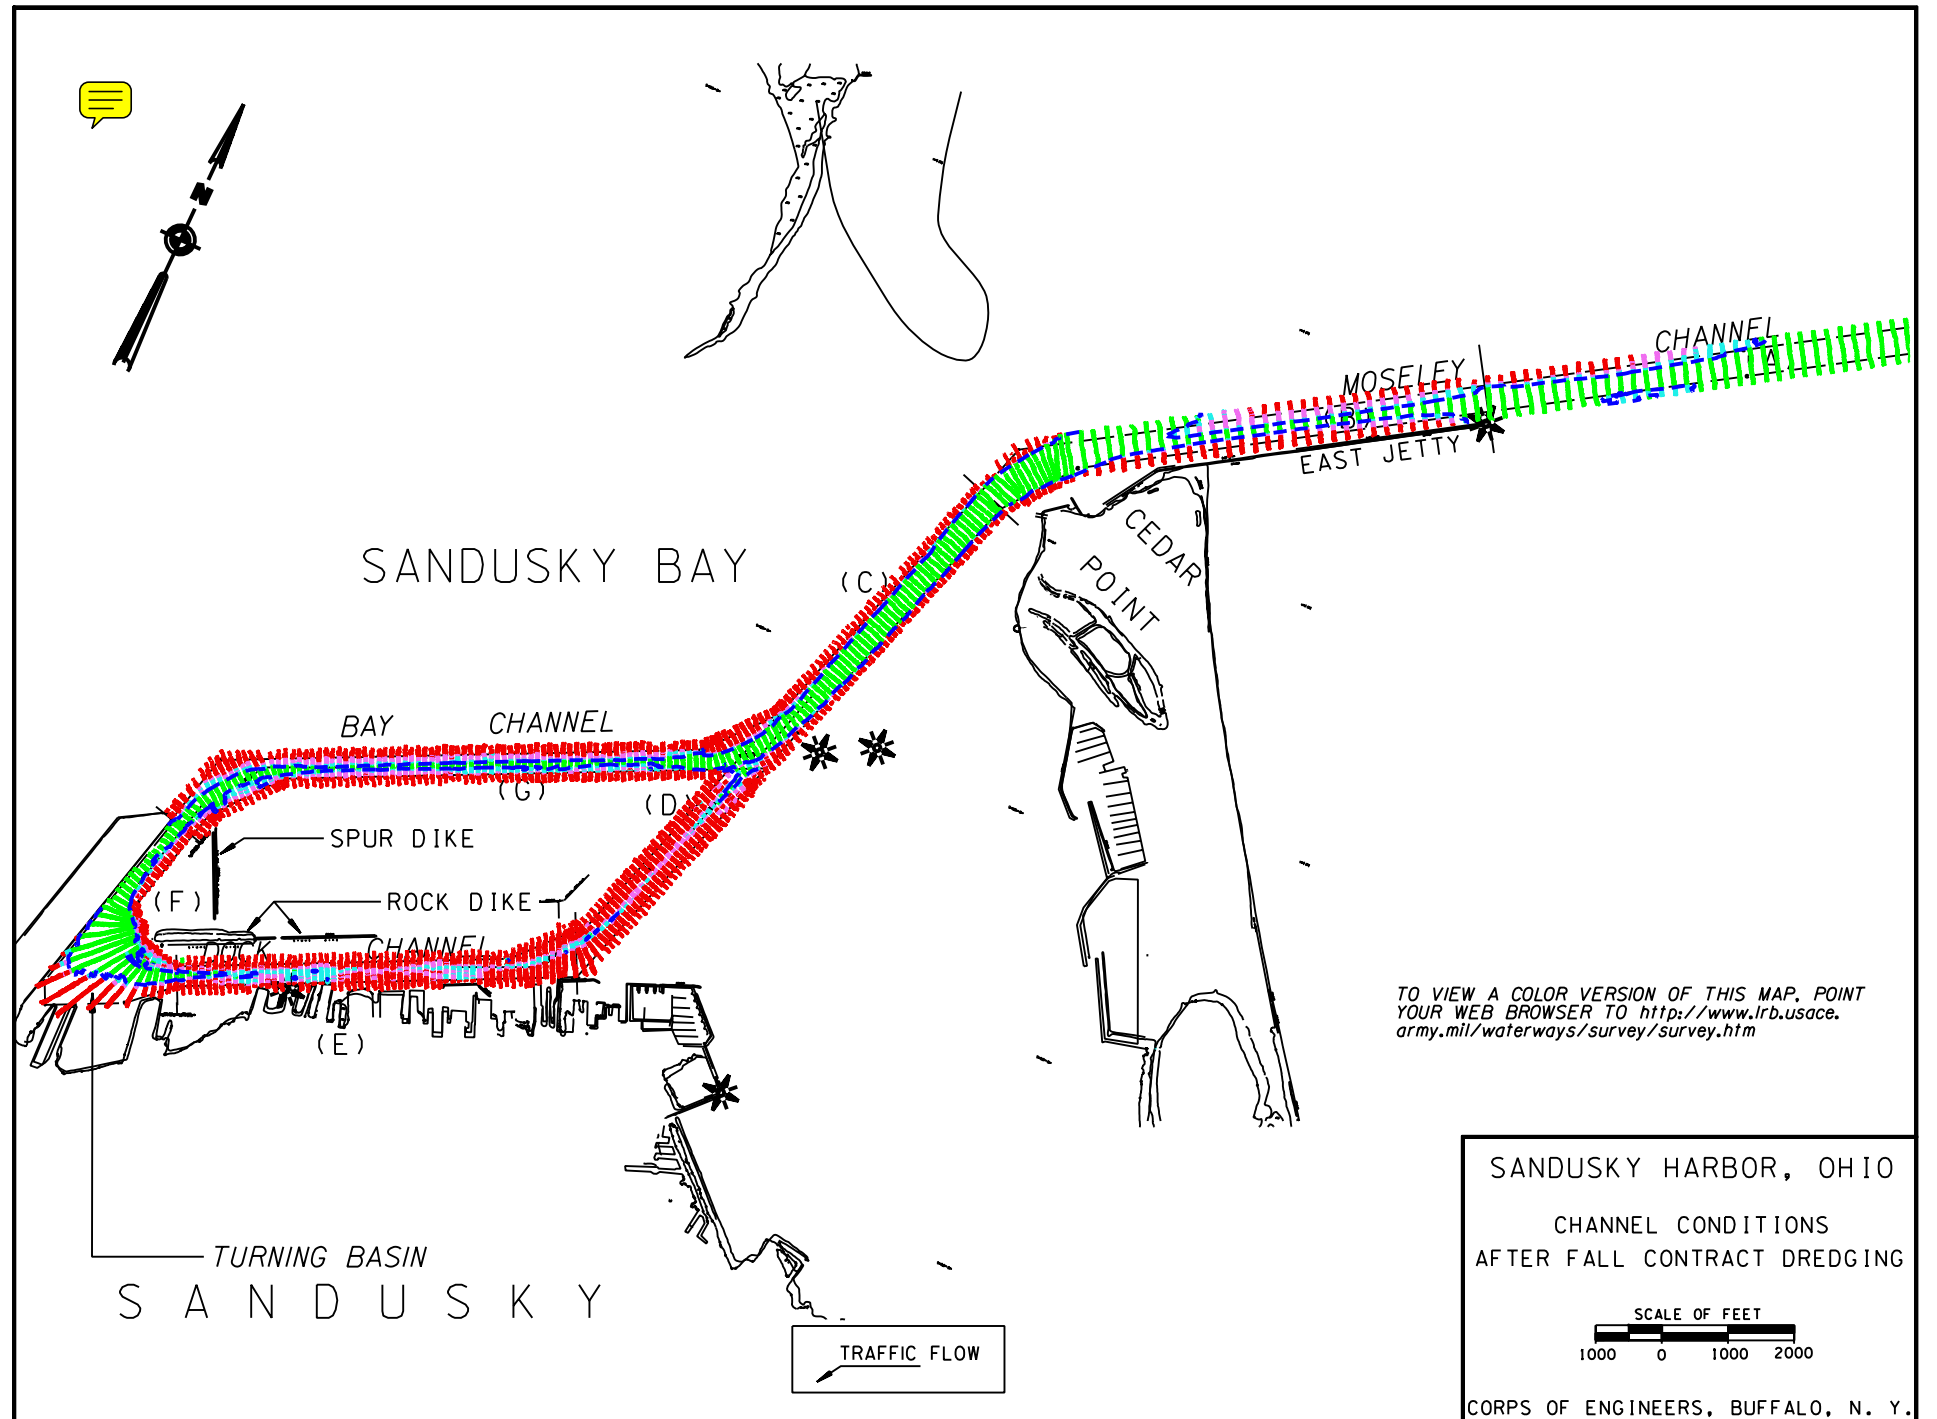
1. Condition surveys performed within the Federal navigation Channel at Sandusky Harbor, Ohio during the month of September 2004 indicate shoaling has reduced depths to those shown on the attached standard tabular form and channel condition drawings.
